THE STATE OF THE CREEK, 2005

The Clean Creek Program Annual Report

Friends of Deckers Creek

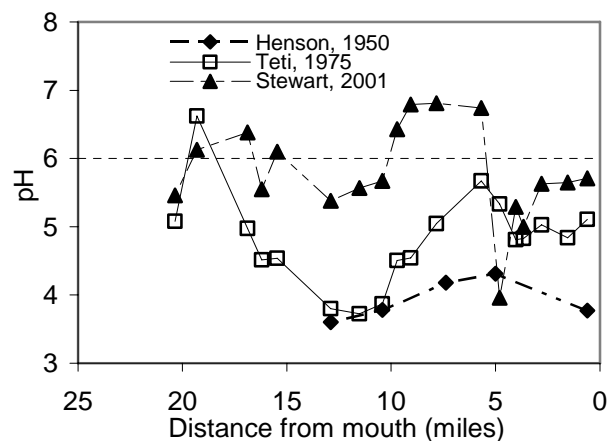
Figure 5: Comparison of pH profiles along Deckers Creek at roughly quarter-century intervals. See the "Sampling sites" section to relate distance from mouth to well-known landmarks.

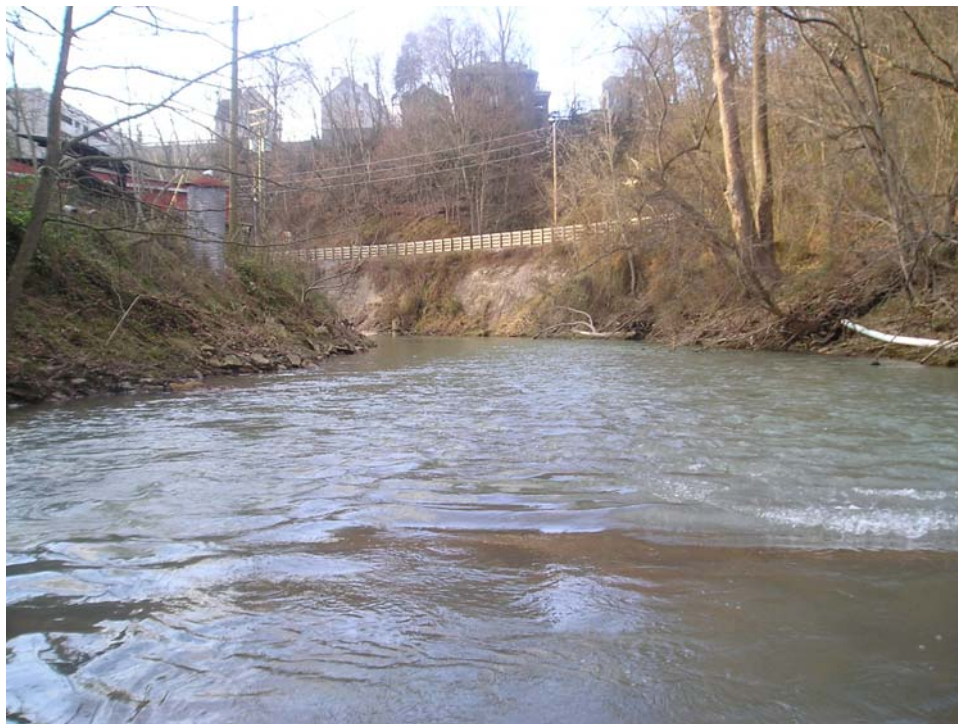
Photo 1: Deckers Creek at Valley Crossing. Gray, upright cylinder at left is USGS gauge. Rail-trail fence is in the background.

Deckers Creek at Valley Crossing (Photo 1). This site is representative of the lower reaches of Deckers Creek, where its waters are not far from the Monongahela River. Users of the rail-trail frequently mention seeing large fish in this segment of the creek. A USGS gauging station at this site records water height and posts it to the Web at half-hour intervals (Box 4). When it rains, a combined sewer overflow discharges to Deckers Creek in this stretch, and often provides a dramatic demonstration of bacterial sources that enter Deckers Creek in its lowest three miles. Data from this site also reveal what the creek contributes to the Monongahela River.

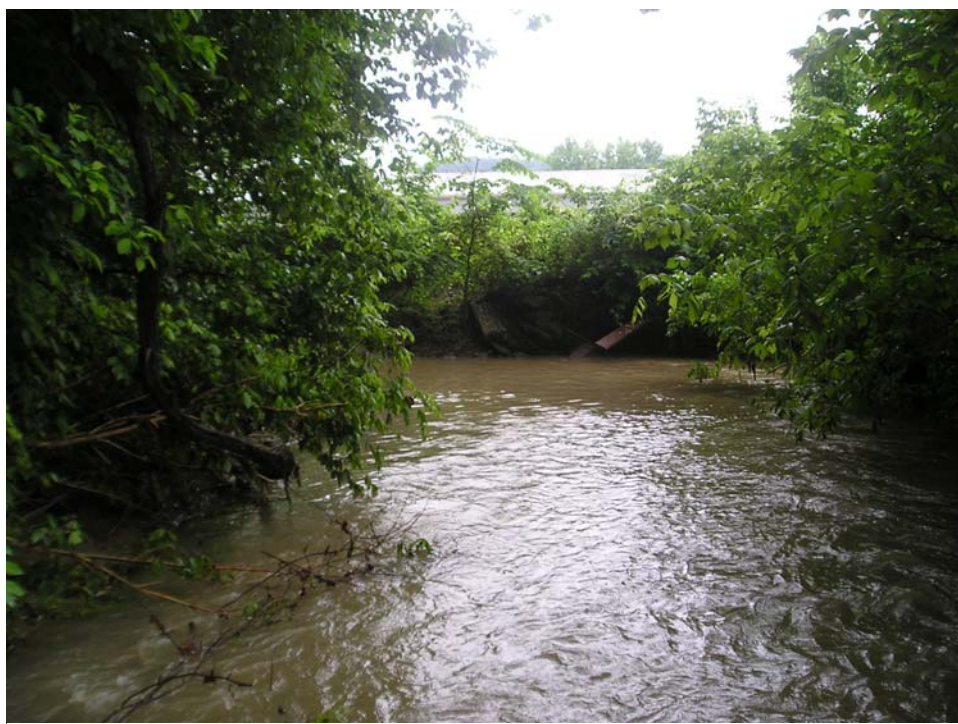
Photo 2: Aarons Creek next to Greenbag Road near its confluence with Deckers Creek. A pool at the bend in the creek in this picture holds the most diverse group of fish in the watershed.

Aarons Creek at the mouth (Photo 2): Aarons Creek generally has water with low pollutant concentrations, and benthic macroinvertebrate and fish communities indicating good water quality. There is some evidence of sediment problems at this site, however. Sediments are often embedded in sand, eliminating some of the interstitial spaces for invertebrate communities, and probably indicating poorly controlled construction practices or collapsing banks upstream. This site is an index of the care with which the land along the northern part of Greenbag Road is being developed.

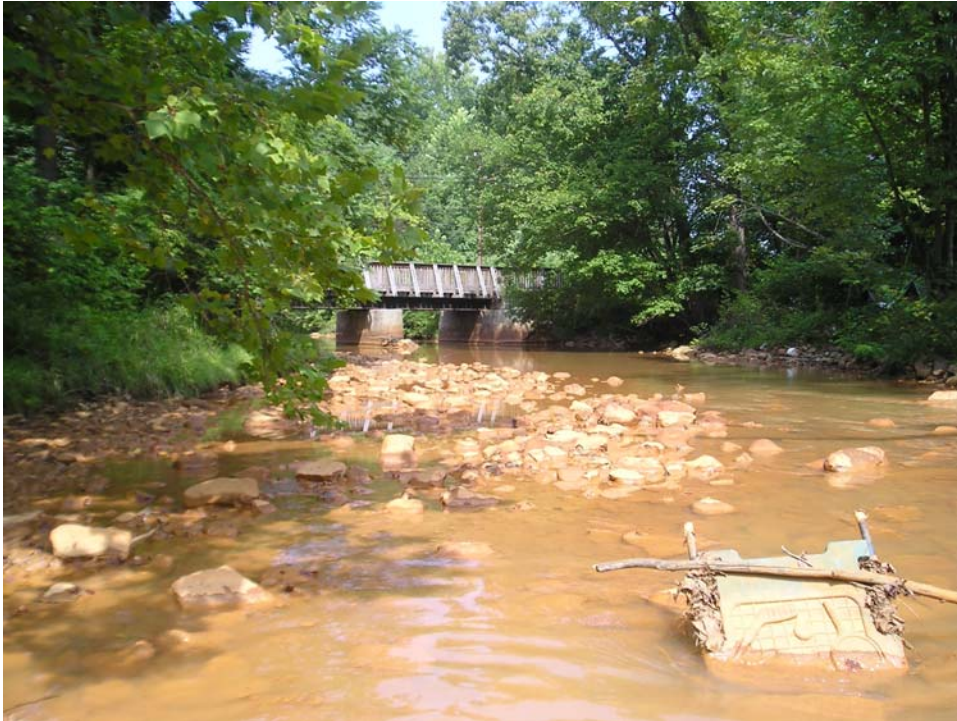
Photo 3: Deckers Creek in Sabraton, just upstream from the rail-trail bridge. Iron from the Richard mine colors the creek most when streamflow is low.

Deckers Creek in Sabraton (Photo 3): This site represents a long segment of the creek that is degraded by the water from the abandoned Richard mine. Water at this site is often red, sometimes green, and almost always turbid. Metals coming out of a dissolved form and turning into solid particles account

for much of this turbidity. FODC hopes that those crossing the creek on the rail-trail at this site will witness improvement in the creek rapidly, once the problem of the Richard mine is solved.

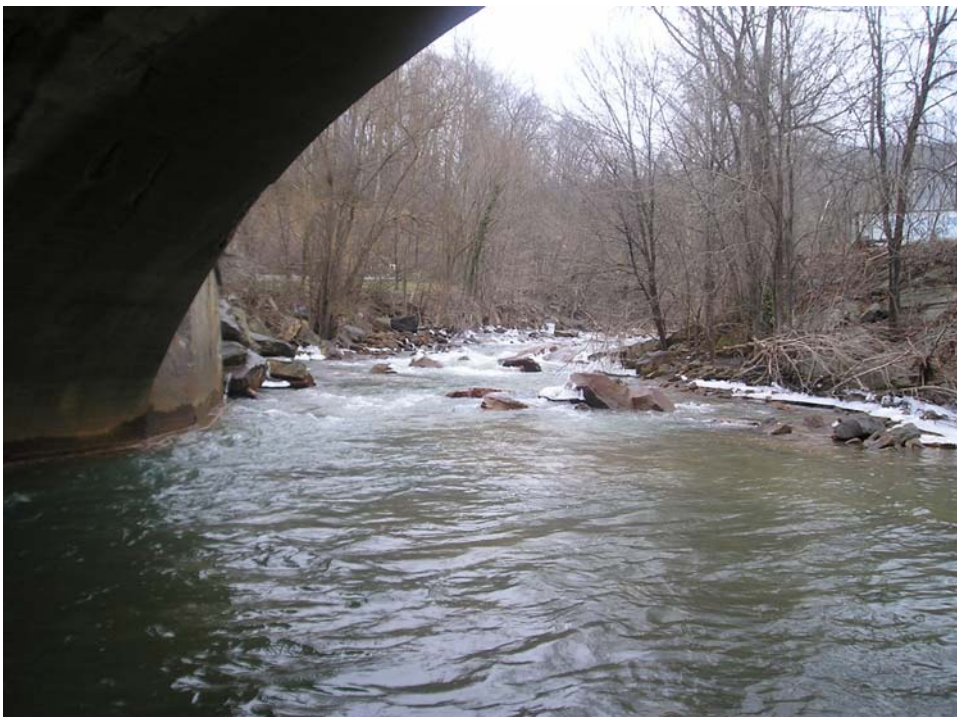
Photo 4: Deckers Creek under the Dellslow bridge. This area below the steep terrain of the gorge but above the Richard mine holds the richest fish community in the mainstem.

Deckers Creek at the Dellslow Bridge (Photo 4): This site is usually one of the best sites for fish in the watershed. The creek at this point is large enough to hold a sizable community of sizable fish. It is cool and aerated after passing through a long, steep, rocky gorge. Its water is also well buffered after passing an area with limestone bedrock, limestone mines, and no AMD. Large boulders and exposed bedrock make pools and riffles, providing the “structure” important for fish habitat.

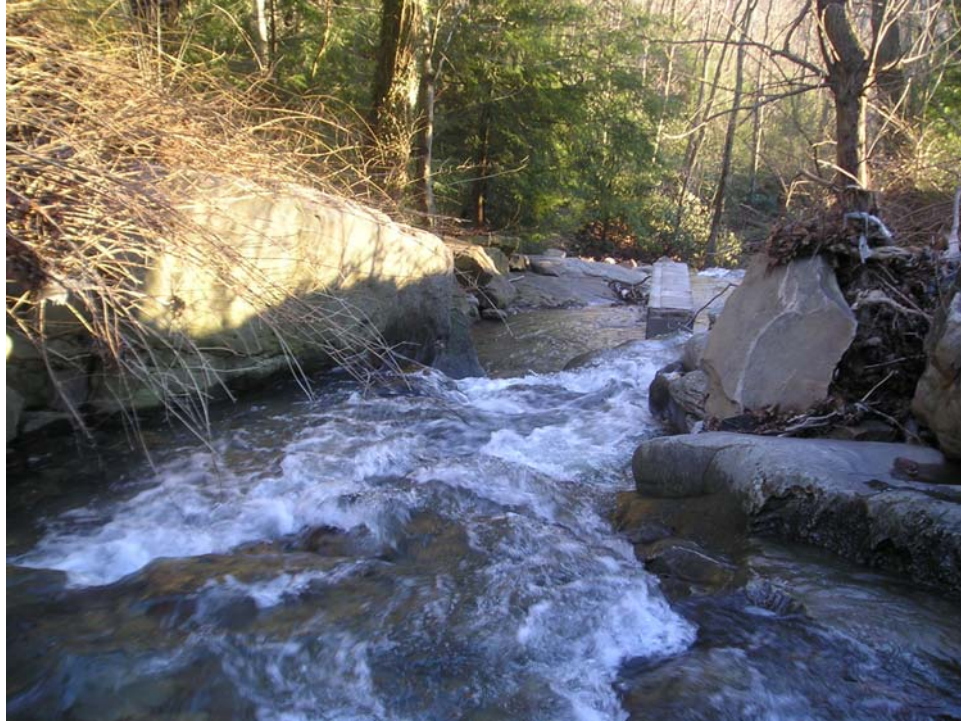
Photo 5: Tibbs Run just downstream from the lower bridge on Tyrone Road

Tibbs Run at the crossing of Tyrone Road (Photo 5): Tibbs Run flows into Deckers Creek just upstream from Dellslow. It is one of the four largest tributaries of Deckers, but it is also important as a possible fish refuge when occasional surges of acidic water come down Deckers Creek past Pioneer Rocks. It is not a spacious refuge, however. It is steep and rocky, and there are a number of small falls in its first quarter mile. It sometimes carries large loads of bacteria from residential areas.

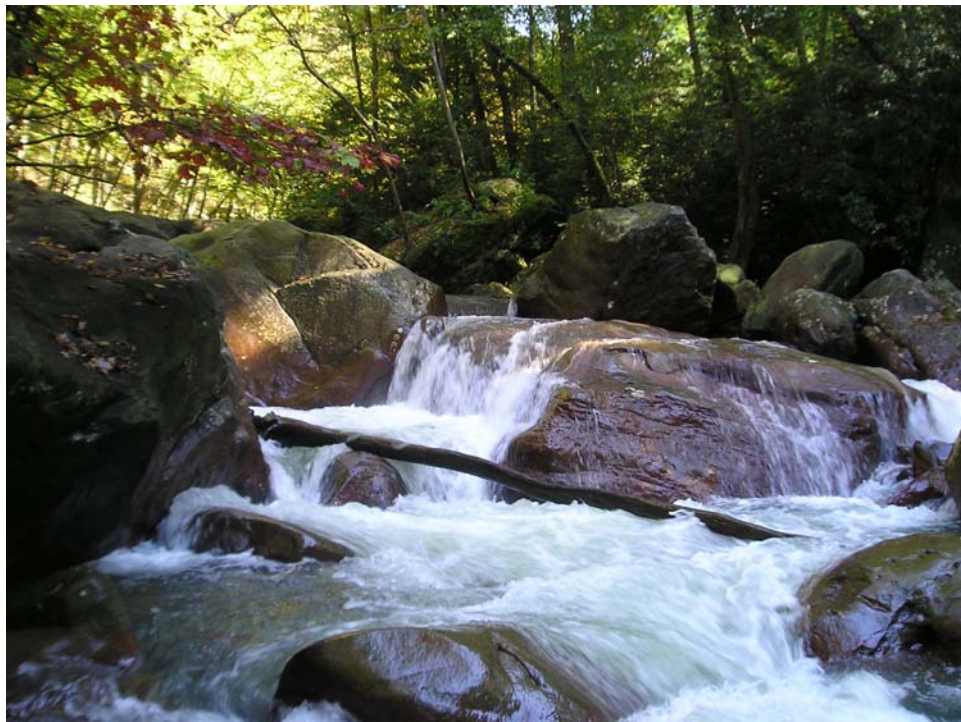
Photo 6: Rapids just upstream from Blue Hole in the gorge segment of Deckers Creek

The Deckers Creek Gorge (Photo 6): This site was chosen as the hallmark site of the Deckers Creek at its wildest. The segment is of special interest to anglers because it physically resembles trout habitat, even though the creek gets too warm to sustain reproducing trout populations. This gorge section has a gradient of 200 feet in 0.7 mile. The creek itself winds past and pours over car- to house-sized rocks and bedrock ledges.

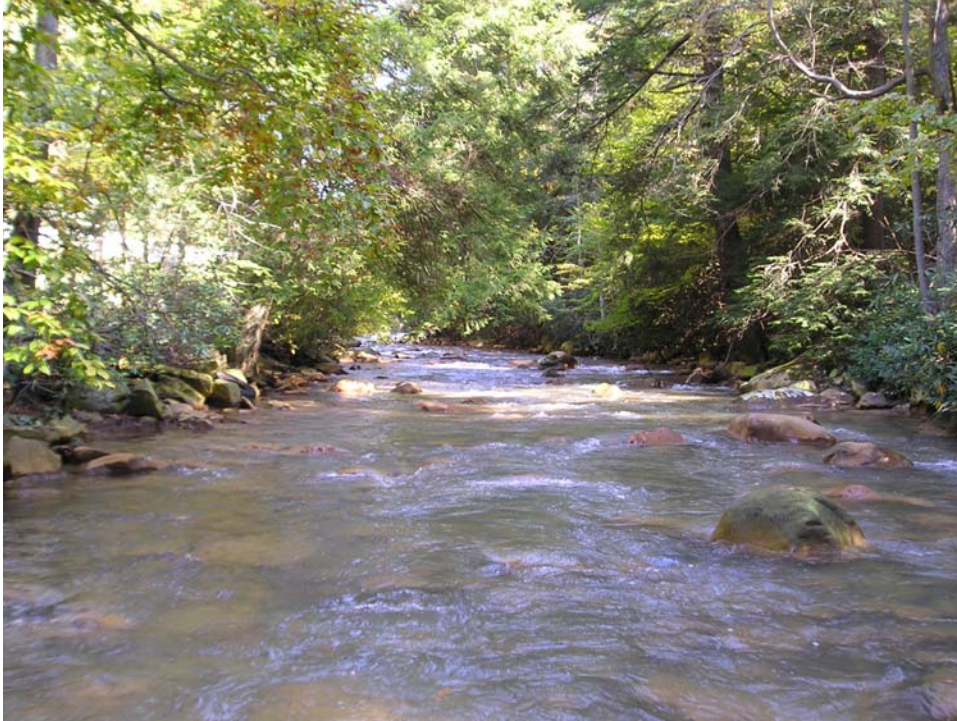
Photo 7: Deckers Creek at the County Line. It flows out of Preston and into Monongalia County

Deckers Creek at the Monongalia/Preston County Line (Photo 7): This site shares many of the physical characteristics of the site in the gorge. It differs in that the water at this point has not passed the limestone mines. This area is thus more likely to experience episodes of acidic or metal-laden water. The streambed is dominated by softball- to car-sized rocks rather than the larger rocks in the lower gorge.

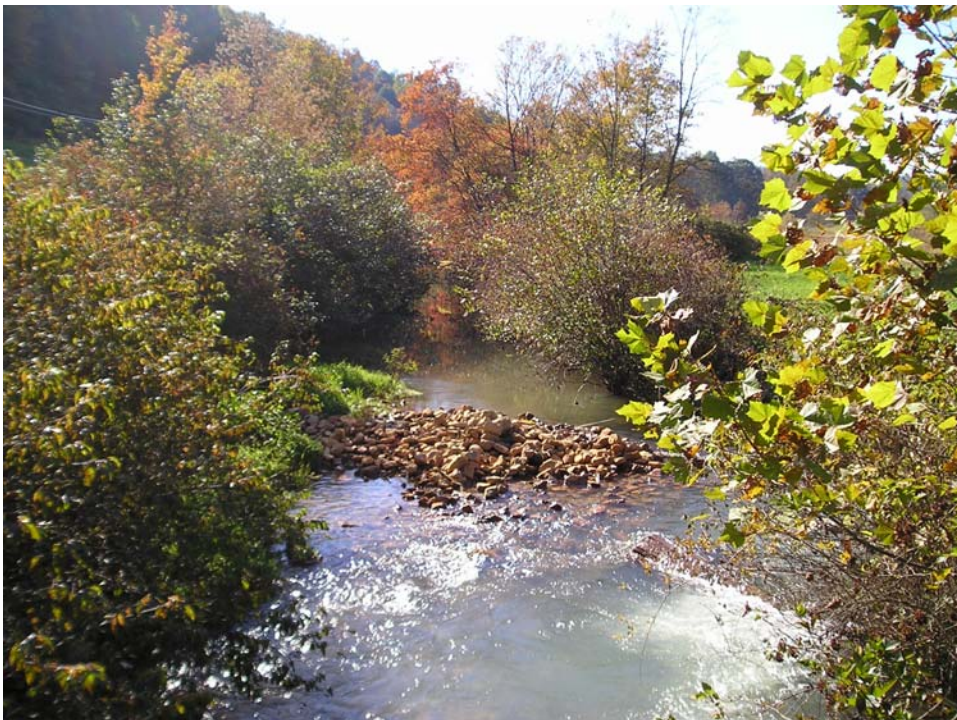
Photo 8: Deckers Creek looking upstream from Masontown. The rock pile appeared in late 2002 or early 2003, and is diverting water to the the bank on the right of the photograph.

Deckers Creek at Masontown (Photo 8): This segment occurs at the downstream end of a calm, three-mile wooded segment. It is also at a parking area for the rail-trail. The field at this site is a large reclaimed area. A layer of coal spoil is visible where Deckers Creek has eroded the bank over the last few years. Sediment in the water just upstream from Masontown makes a reddish cloudiness when disturbed, suggesting decades of metal deposition. At Masontown the slope and current pick up, and gravel and pebbles cover the streambed.

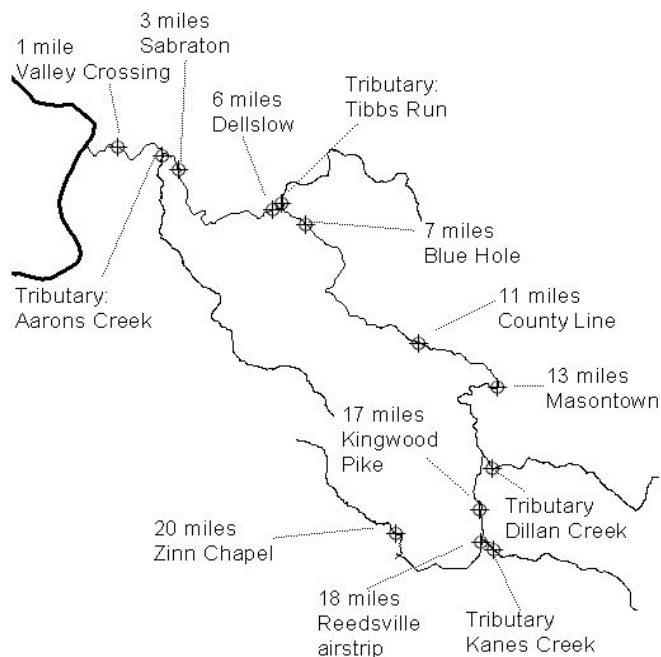
Figure 7: Deckers Creek and major tributaries with distance to mouth noted for monitoring locations. Distances are used in x-axis of many of the following water quality graphs.

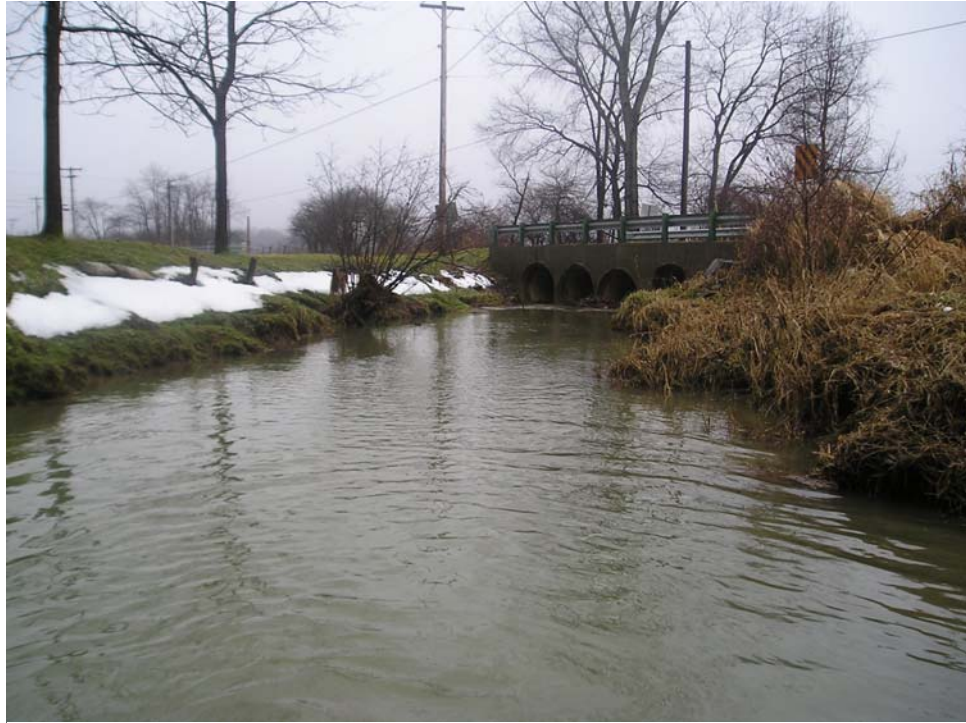
Photo 9: Dillan Creek, just upstream from Burke Road

Dillan Creek at Burke Road (Photo 9): Dillan Creek is a large tributary with severe AMD in its upper reaches. Its acidity is neutralized, however, before it reaches Deckers Creek. We monitor in a channelized section next to Burke Road.

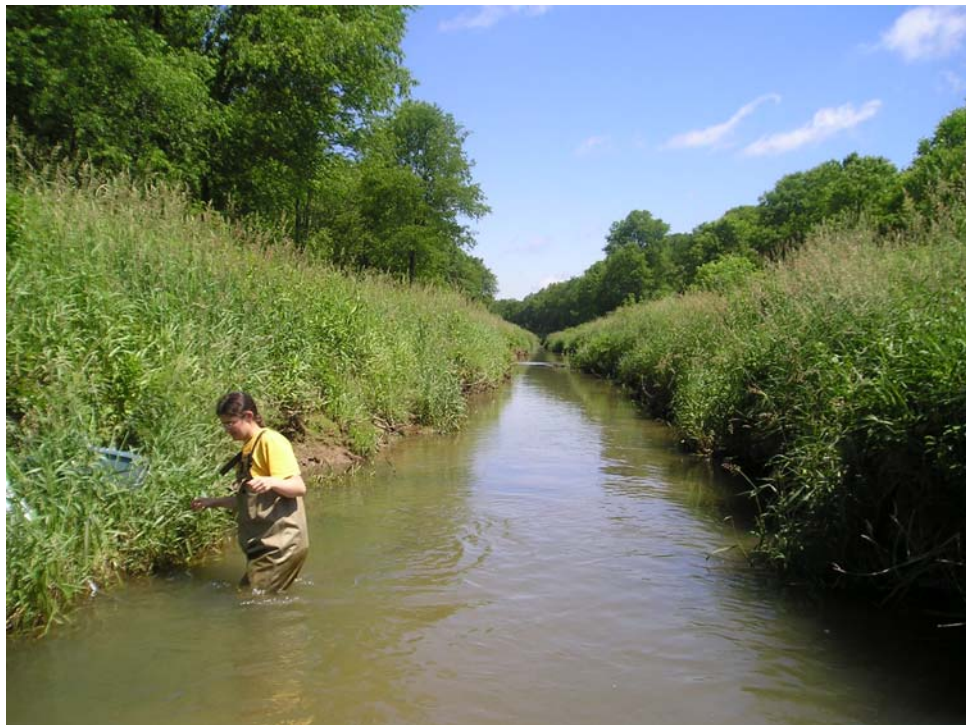
Photo 10: OSM Summer Intern Lina Bird monitoring conditions in Deckers Creek at the Kingwood Pike

Deckers Creek at Kingwood Pike (Photo 10): This site represents the channelized, low-gradient portions of Deckers Creek after it has received the input of one heavily impacted AMD stream, Kanes Creek. The streambed there is mostly sandy, but there is usually soft mud at the edge of the stream.

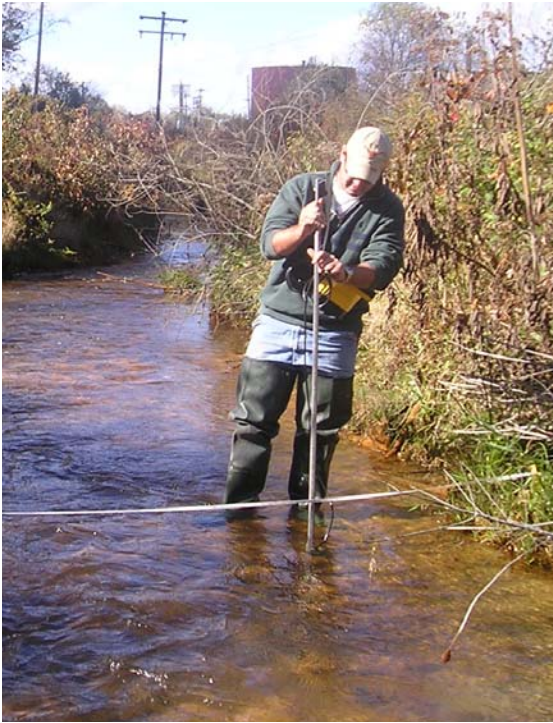
Photo 11: A volunteer makes a measurement of flow in Kaners Creek just downstream from Route 92

Kanes Creek at Route 92 (Photo 11): The Kanes Creek watershed contains a large number of AMD sources. It is the watershed with the most remediation targets in the Deckers Creek watershed. This stream extends the Deckers Creek watershed to within about three miles of Kingwood. The ridges where it rises also hold the origins of Greens Run and Morgan Run of the Cheat River, and Squires Creek of Threeforks Creek, all of which are polluted by AMD.

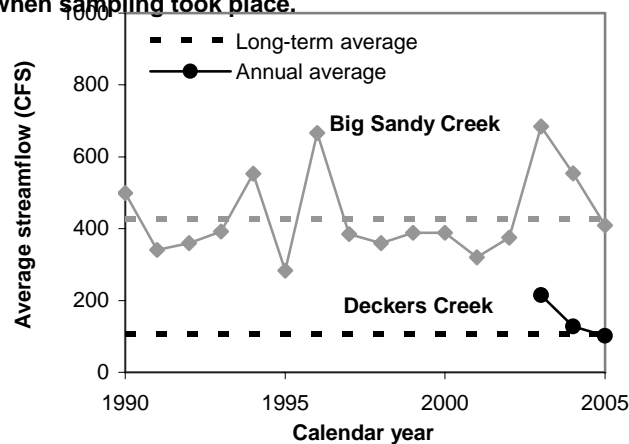
Figure 9: Average streamflow for recent calendar years on Deckers and Big Sandy Creeks

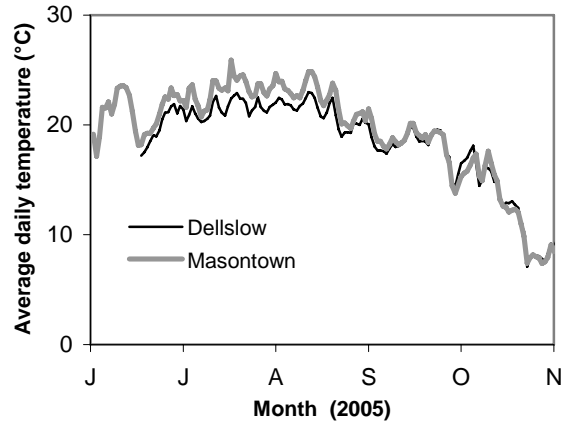
Figure 10: Temperature in Deckers Creek at the top (Masontown) and bottom (Dellslow) of the gorge in 2005.

At both sites, the average temperatures during July, the hottest month, were slightly higher in 2005 than in 2004. The average July temperature rose from 20.2 to 21.5°C in Dellslow, and from 22 to 23.1°C in Masontown

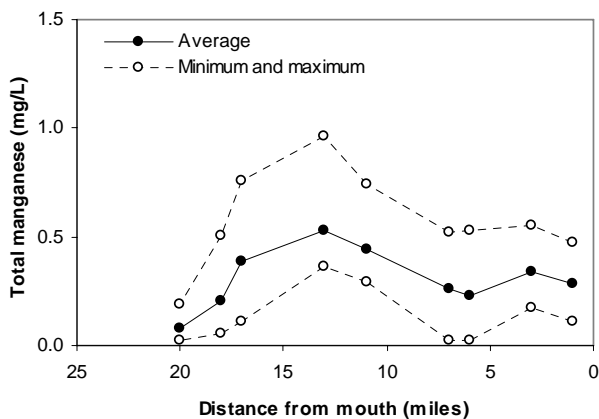
Figure 15: Average, minimum and maximum manganese concentrations in the mainstem of Deckers Creek

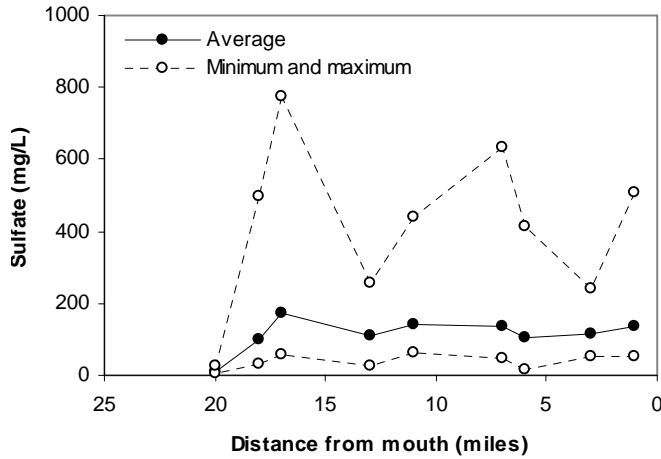
Figure 16: Average, minimum and maximum sulfate concentrations in the mainstem of Deckers Creek

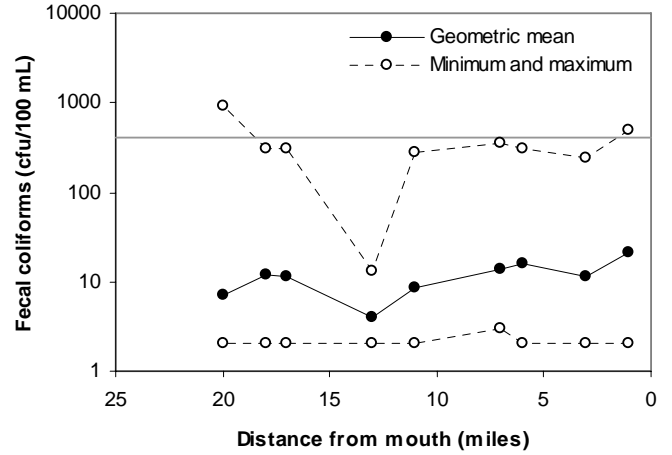
Figure 17: Geometric mean, minimum and maximum fecal coliform counts in the mainstem of Deckers Creek, compared with the water quality standard

Fecal coliform bacteria also occur in Deckers Creek. In the three years of the Clean Creek Program, however, concentrations at sampling times have seldom exceeded 400 cfu/100 mL, which is the level that raises concern about a rarely-sampled body of water, according to the WVDEP (Figure 17). Bacteria in Deckers Creek may come from homes and businesses with inadequate sewage treatment, from sewer overflows during rainy periods, or from wildlife or livestock.

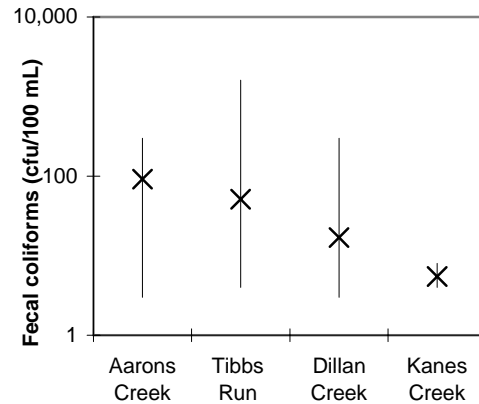
Figure 25: Geometric mean, minimum and maximum fecal coliform counts in tributaries

During the time of this study, only Tibbs Run violated the 400 cfu/100 mL level, indicating impairment by fecal coliform bacteria (Figure 25). Aarons Creek, however, had a higher average geometric mean concentration: 92 cfu/100 mL. Because fecal coliform levels depend so much on the weather near the sampling time, the behaviors of the tributaries is difficult to interpret. The AMD-impaired tributary, Kanes Creek, always had very low bacteria counts.

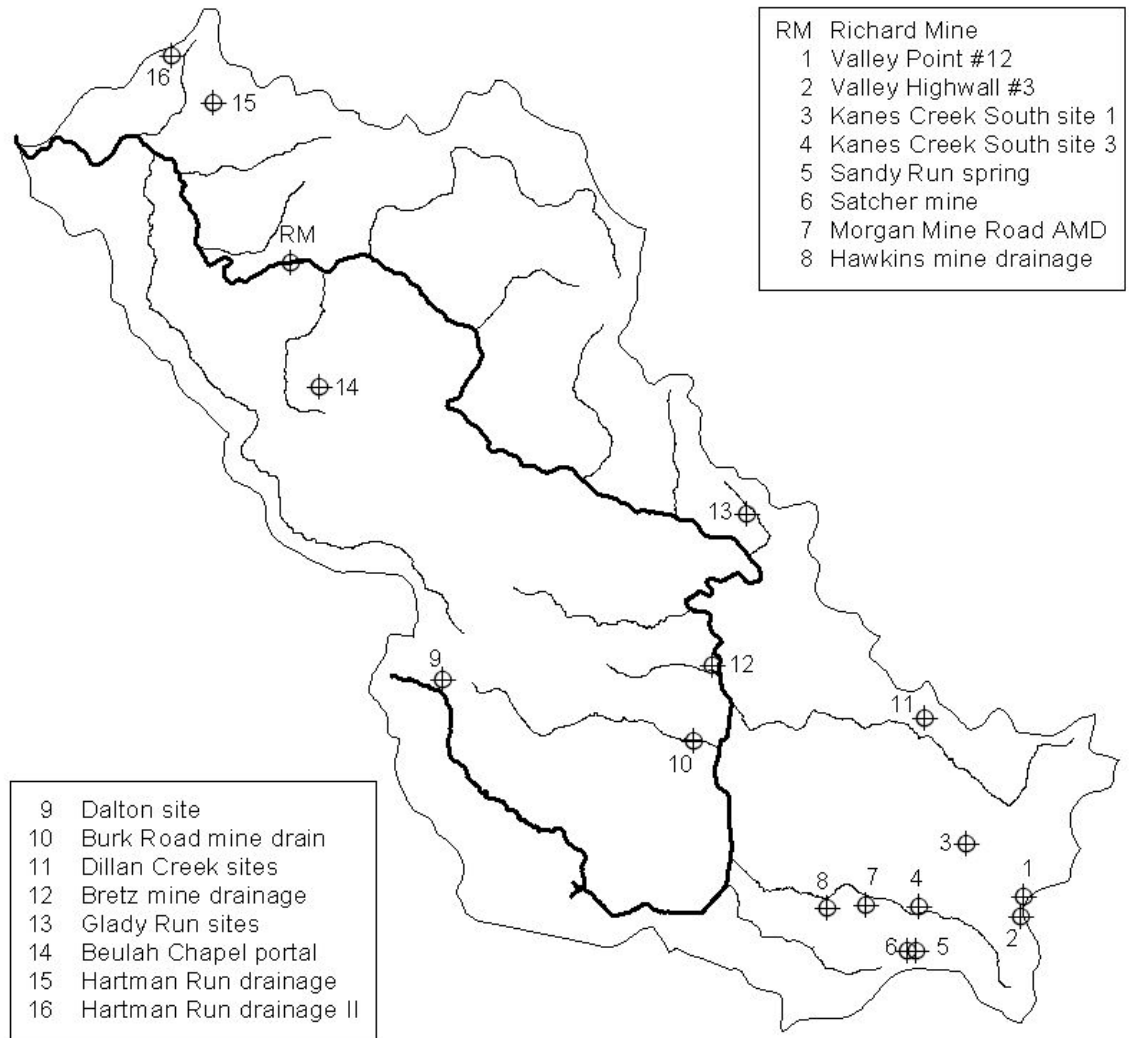
Figure 39: Location of the 17 high-priority AMD sources in the Deckers Creek watershed, listed in the order they are to be addressed

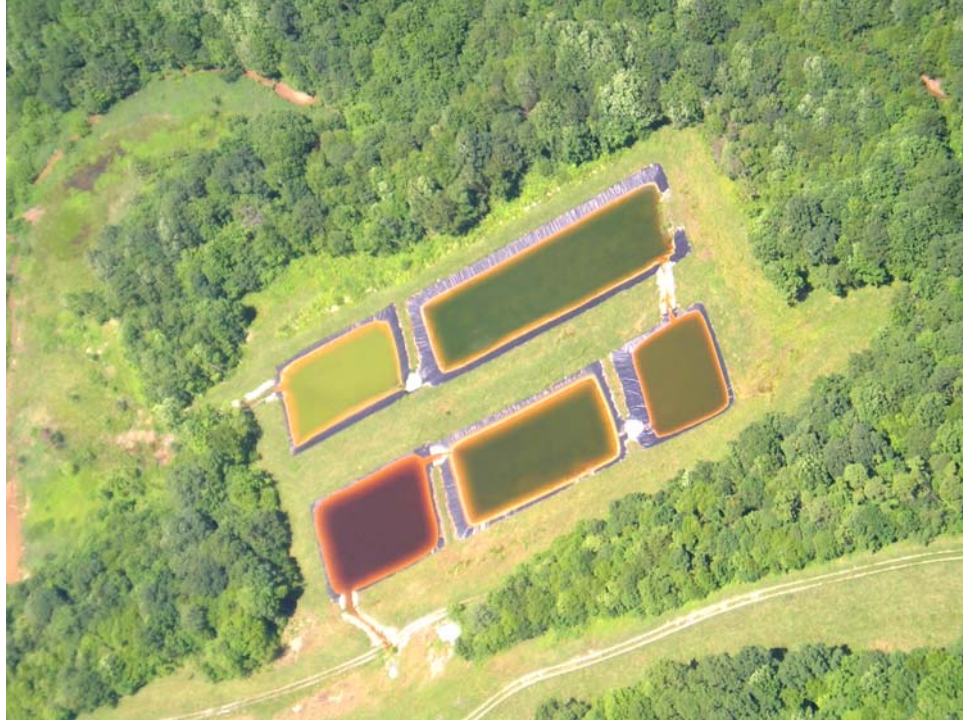
Photo 14: Reducing and alkalinity producing system installed near Kanesh Creek. The lower left pool contains a compost layer covering limestone, and the other basins are settling ponds.

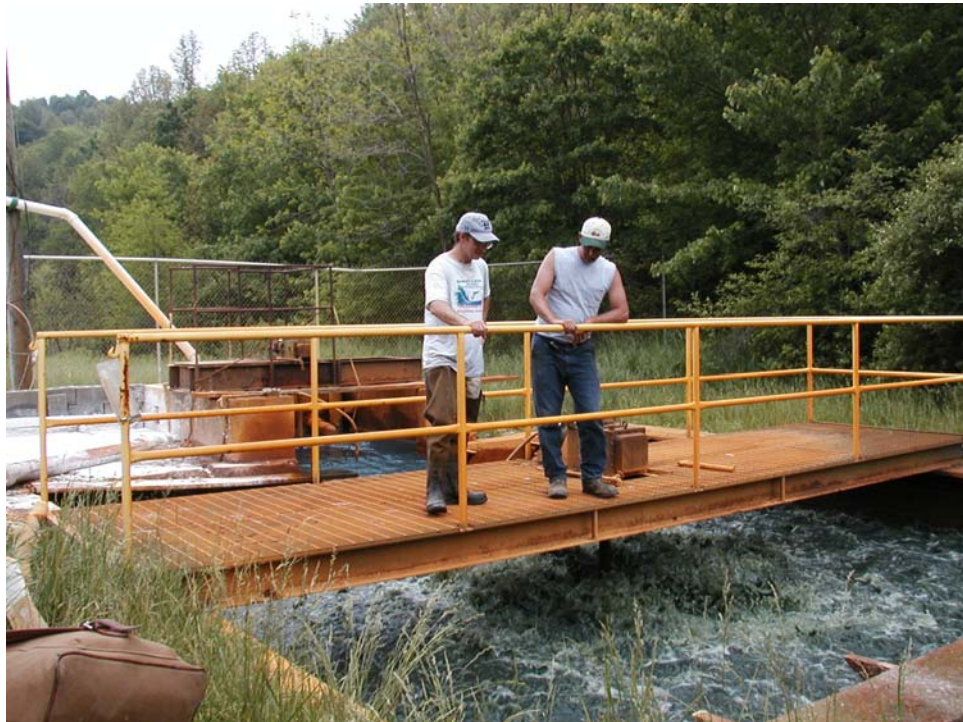
Photo 15: Part of an active AMD treatment plant on Kanesh Creek, run by International Coal Group . Hydrated lime is mixed with AMD just before it enters the mixing chamber. A large propeller under the metal walkway mixes air into the AMD to oxidize iron. After mixing, AMD flows into several large settling ponds.
